Massachusetts Water Resources Authority

MWRA Response to Pipe Break on May 1, 2010

An AWMA Case Study

October 18, 2011

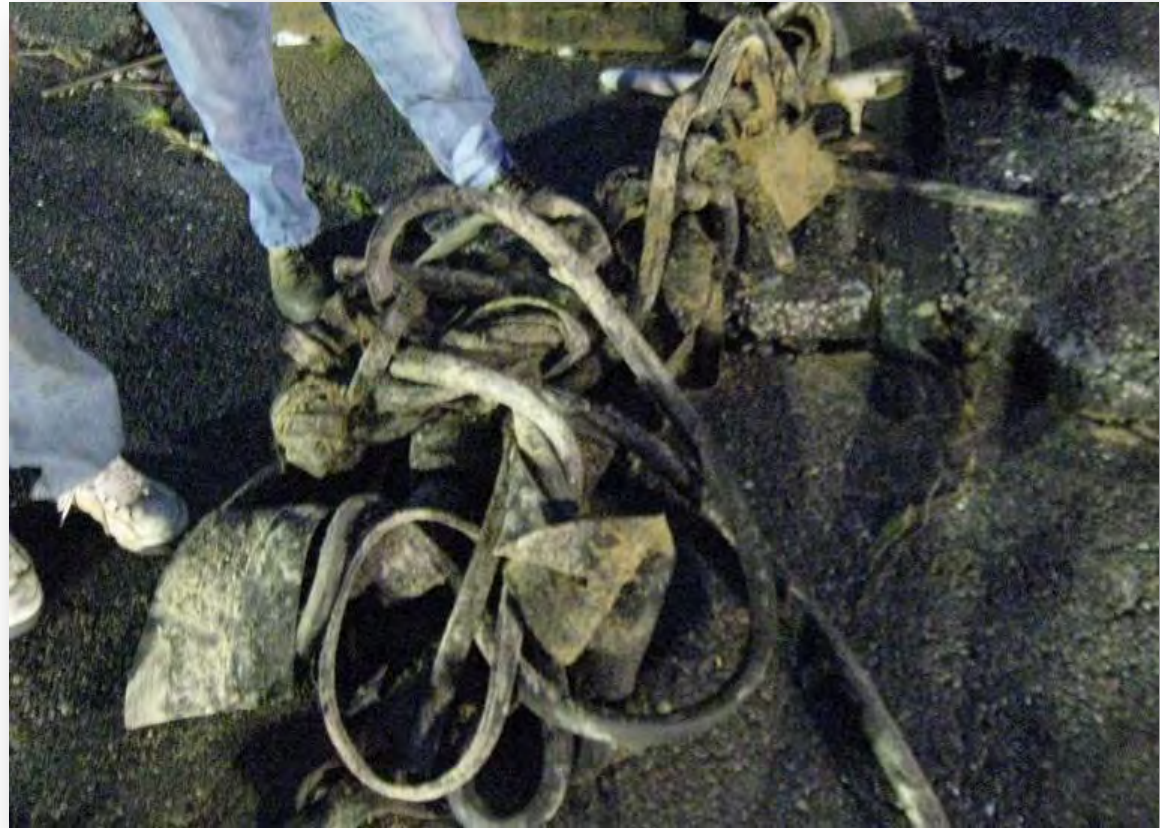
Components Recovered

- Rubber gasket and insulating pad from coupling

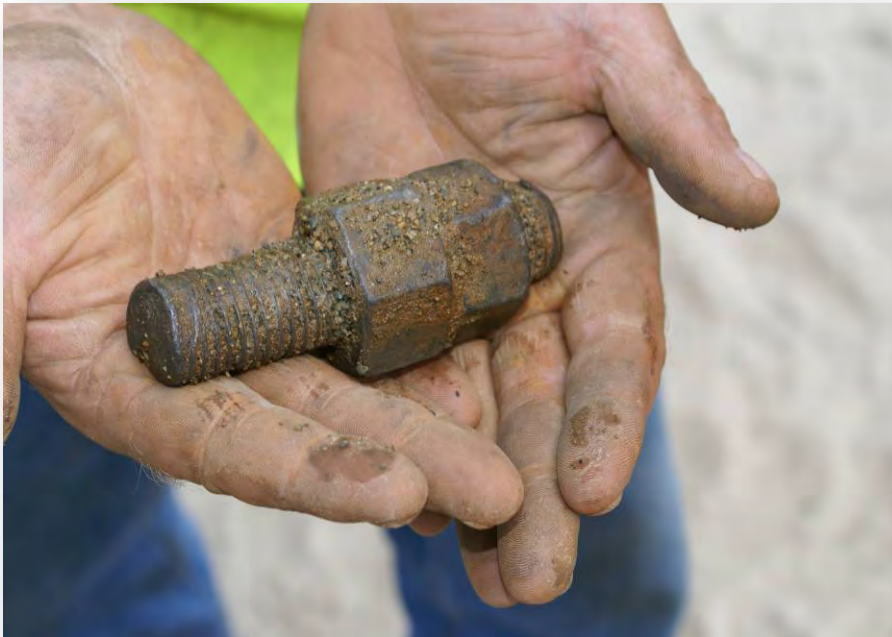
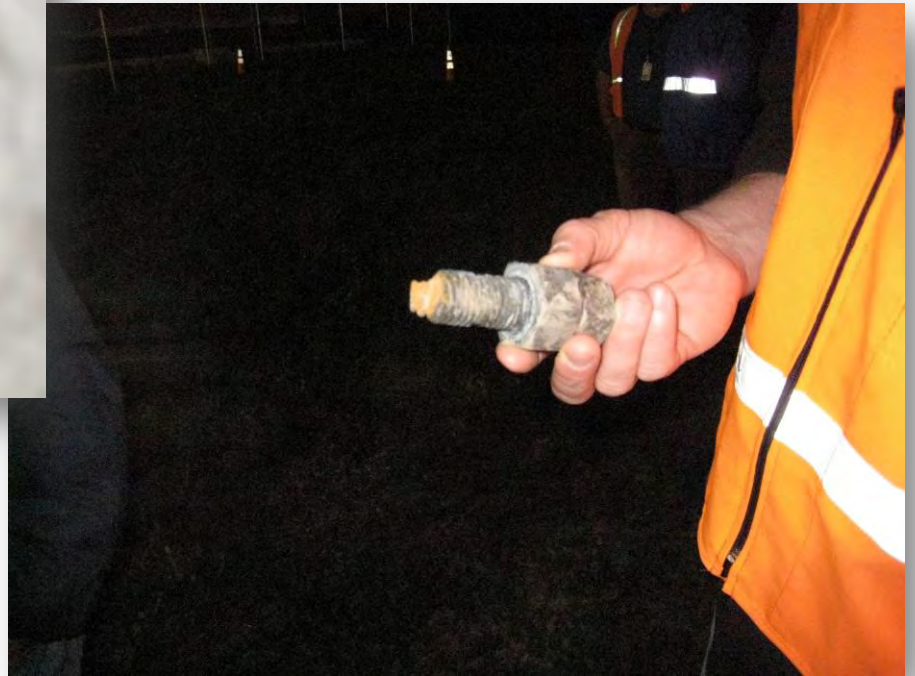
Components Recovered

- One complete bolt and pieces of other

- MWRA received the Panel's report in May 2011
- Panel determined that the cause of the coupling failure was the studs
- Lawsuit has been filed against several parties

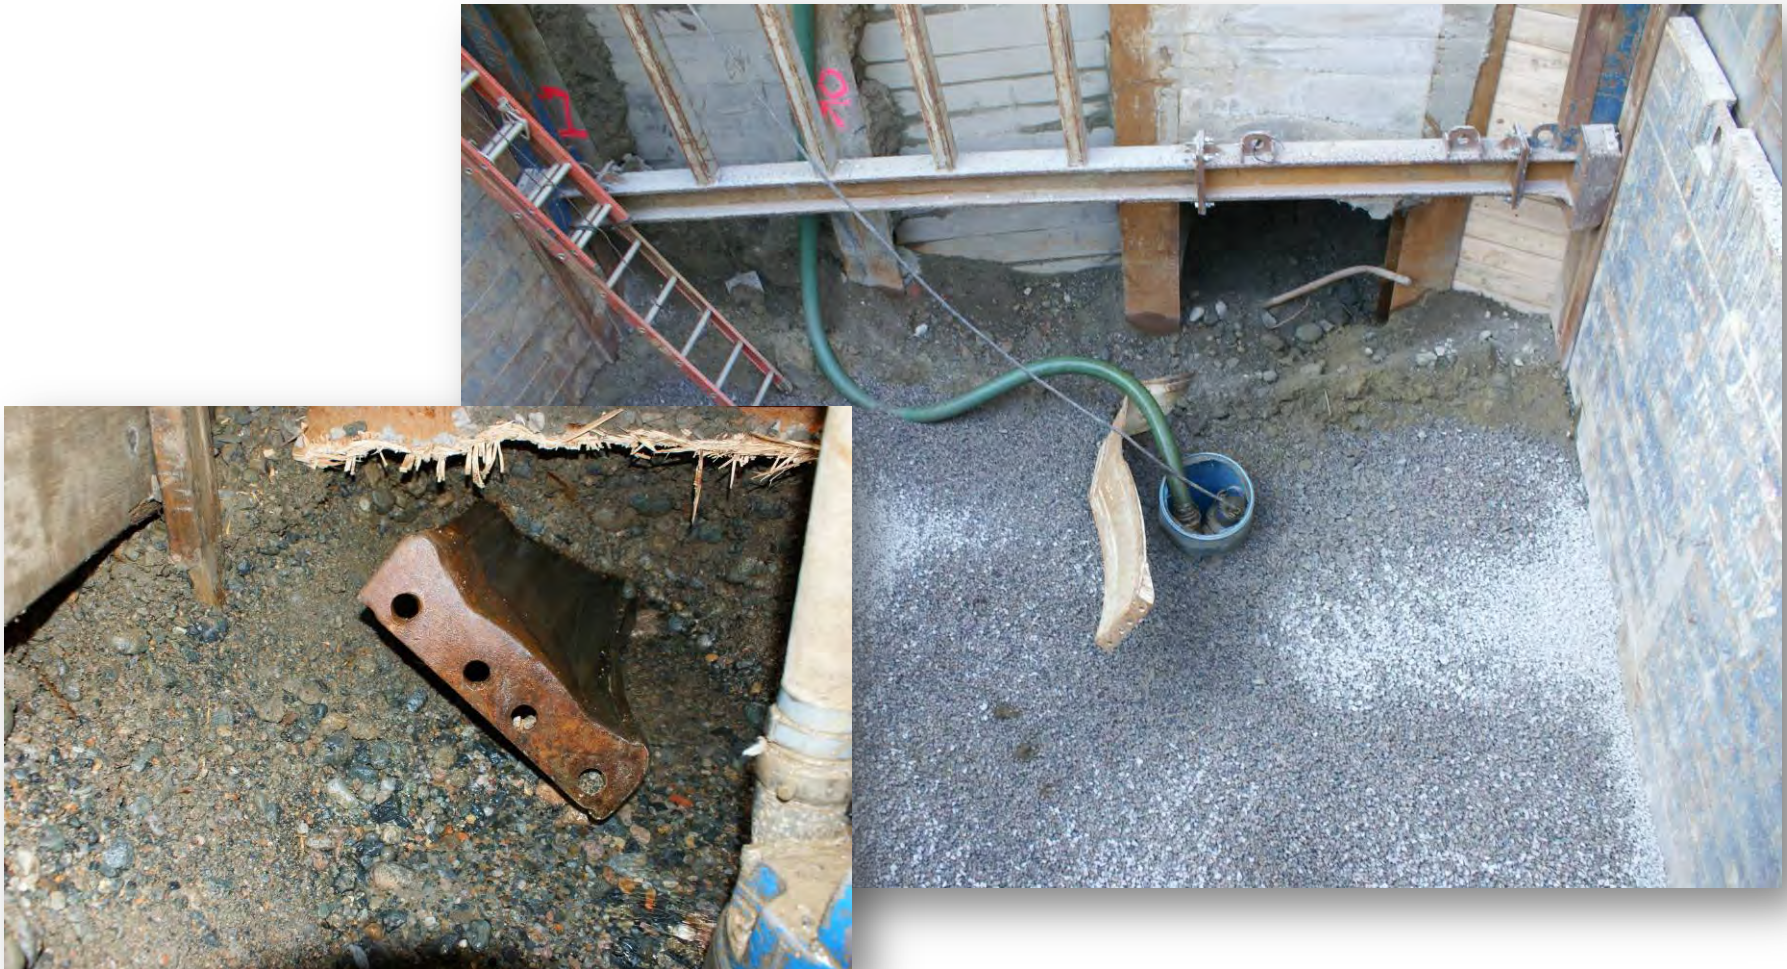
Components Recovered

- Both halves of coupling
