Making Your Buried Assets Last: Optimization of Buried Infrastructure

AMWA Executive Management Conf.

WaterOne

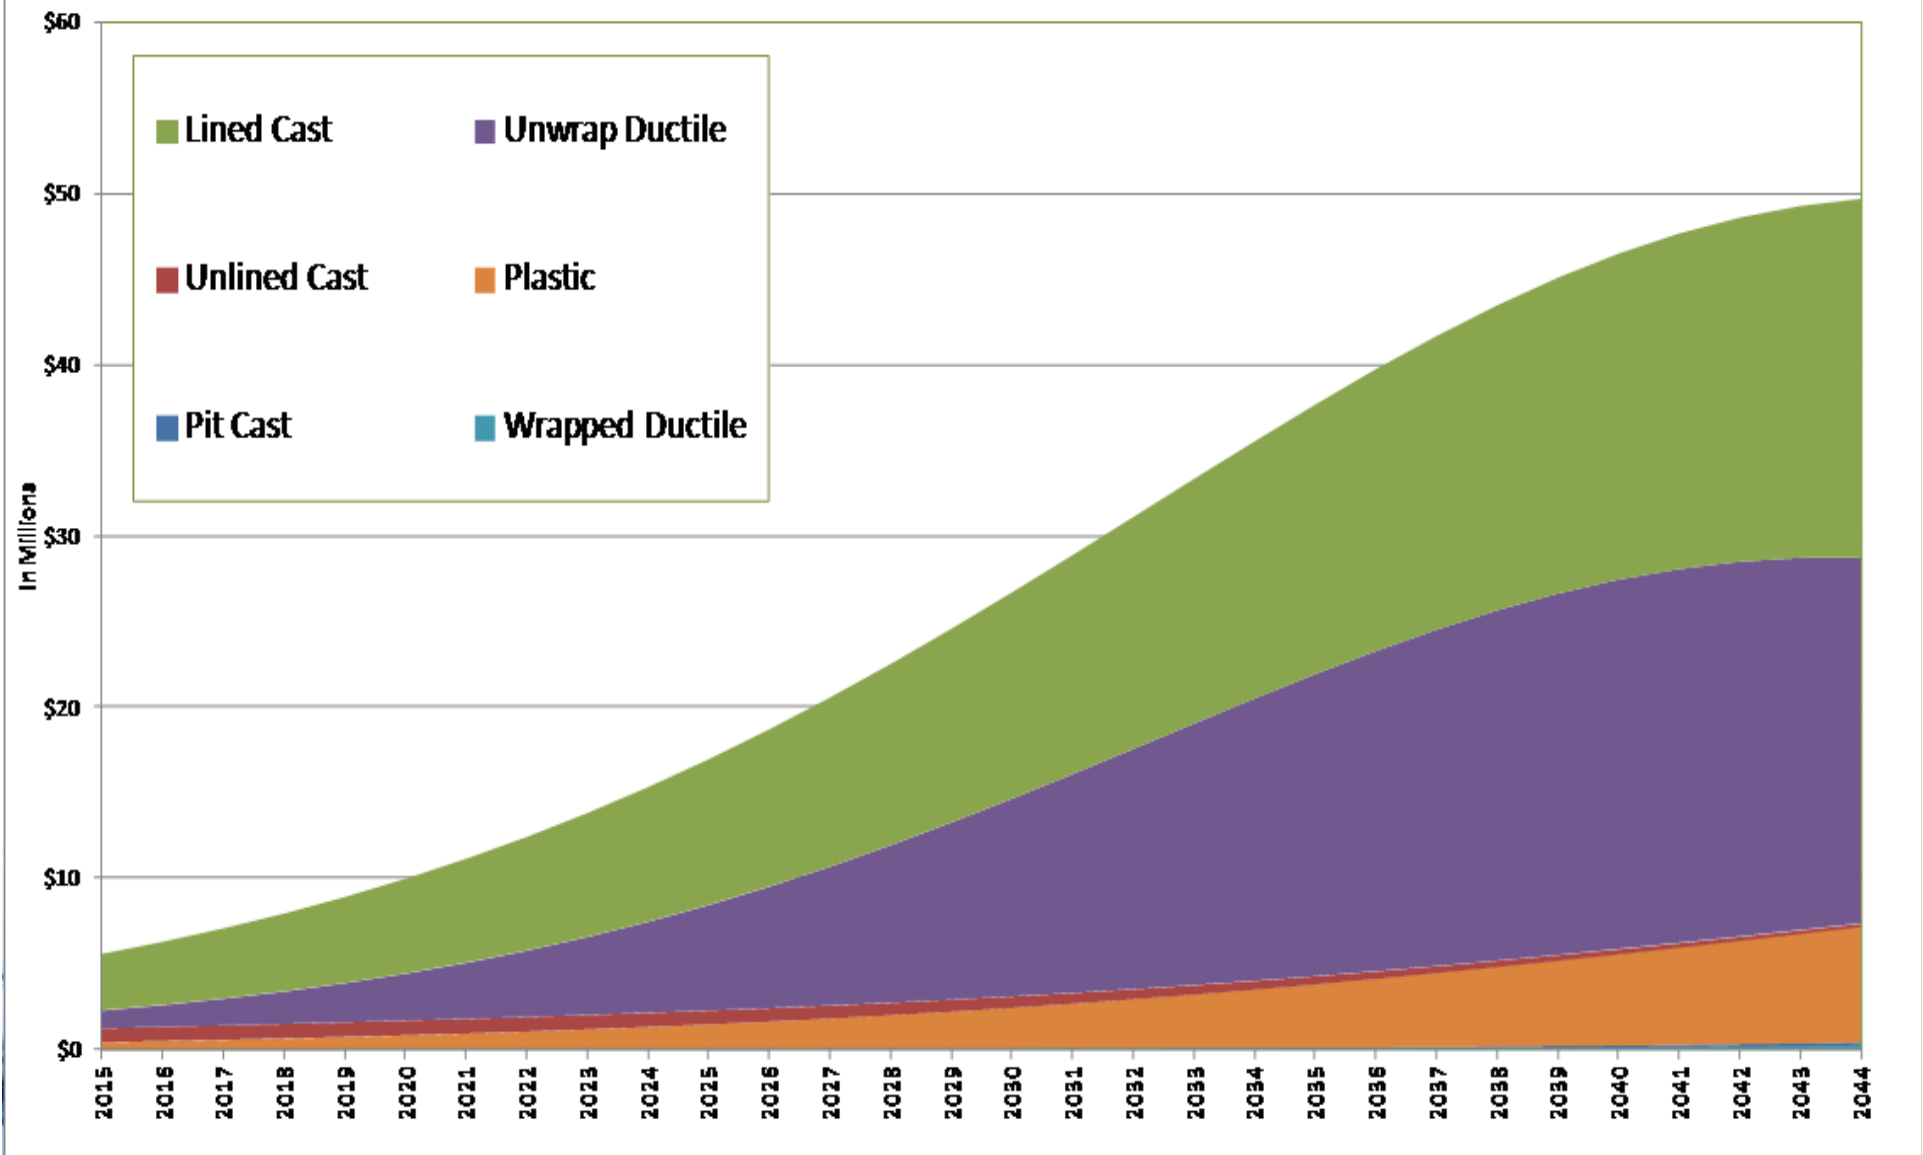
Funding - Nessie Curve

30 Year Distribution Main Replacement Projection

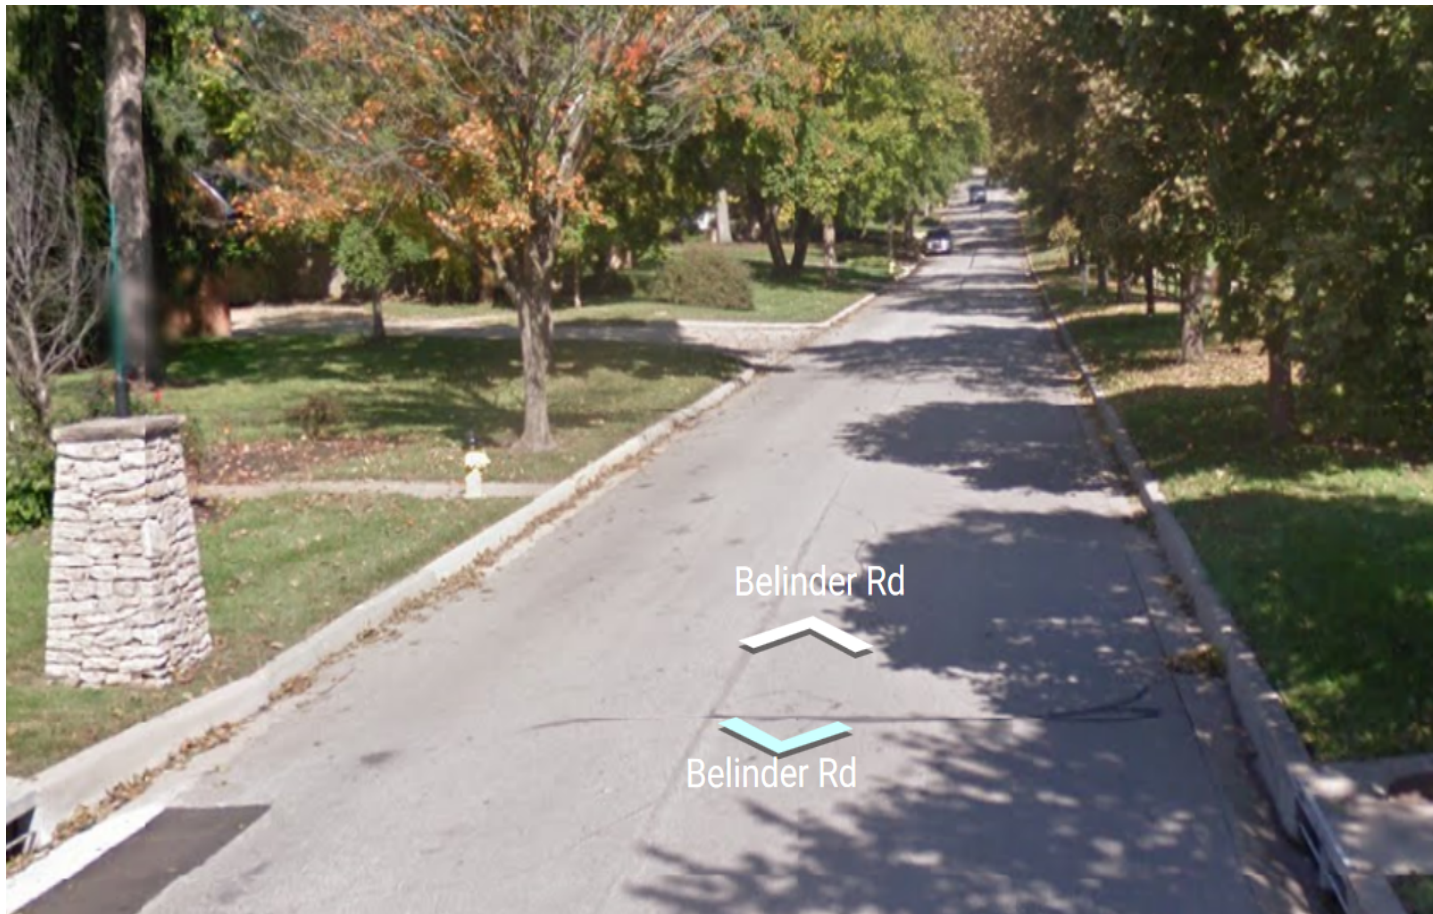
Case Study – Dist. Main

- 2,700 ft. , 6” CI pipe, installed in 1940
- Based on 10 point criteria, should be replaced.
- But should we???

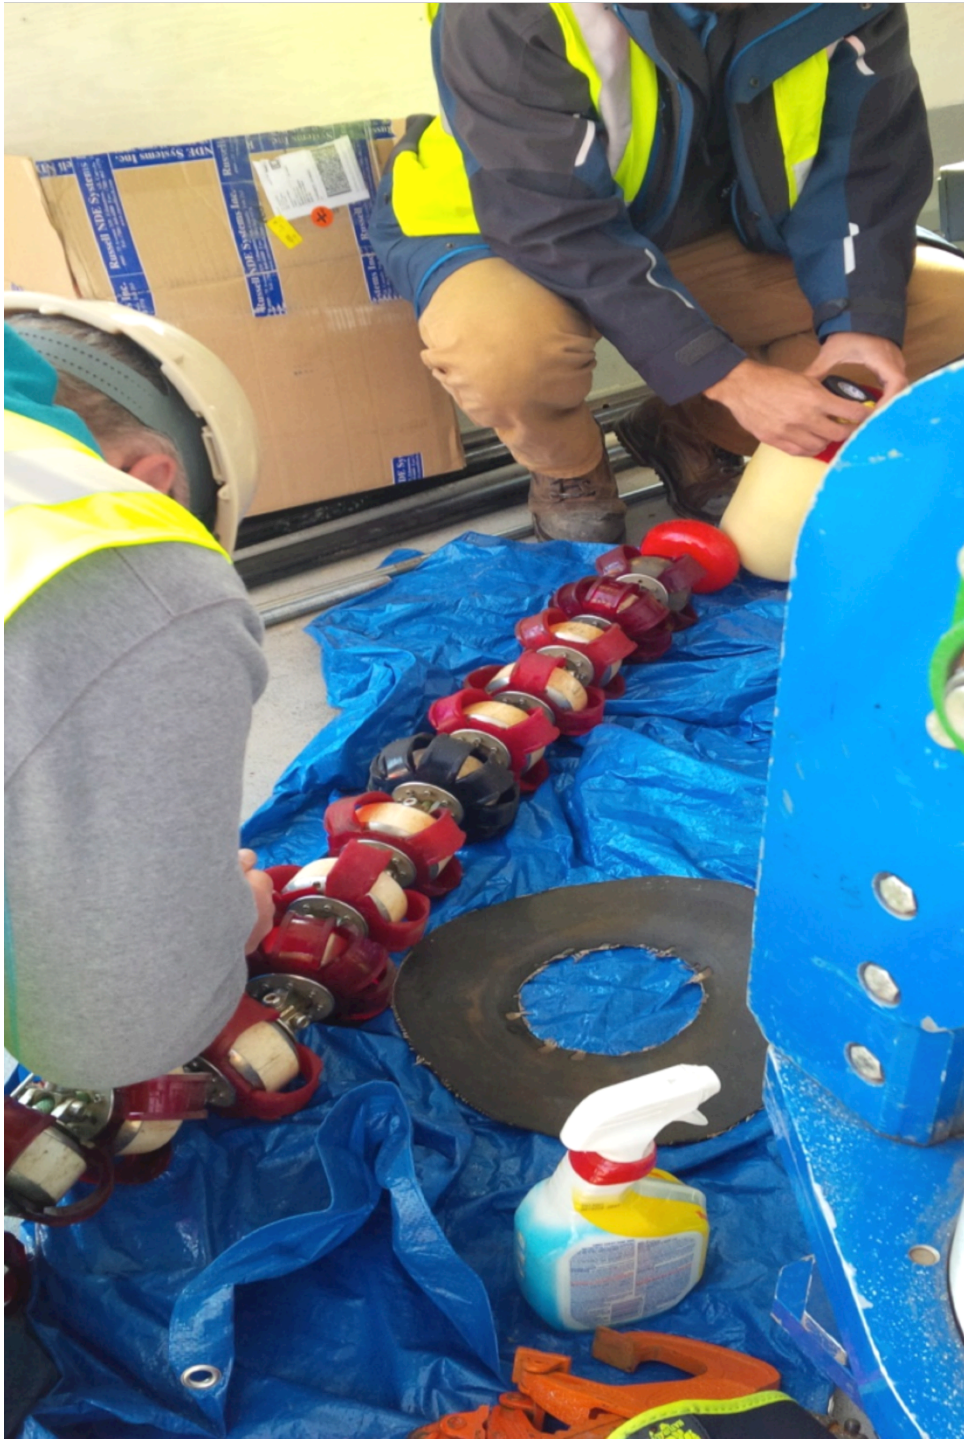
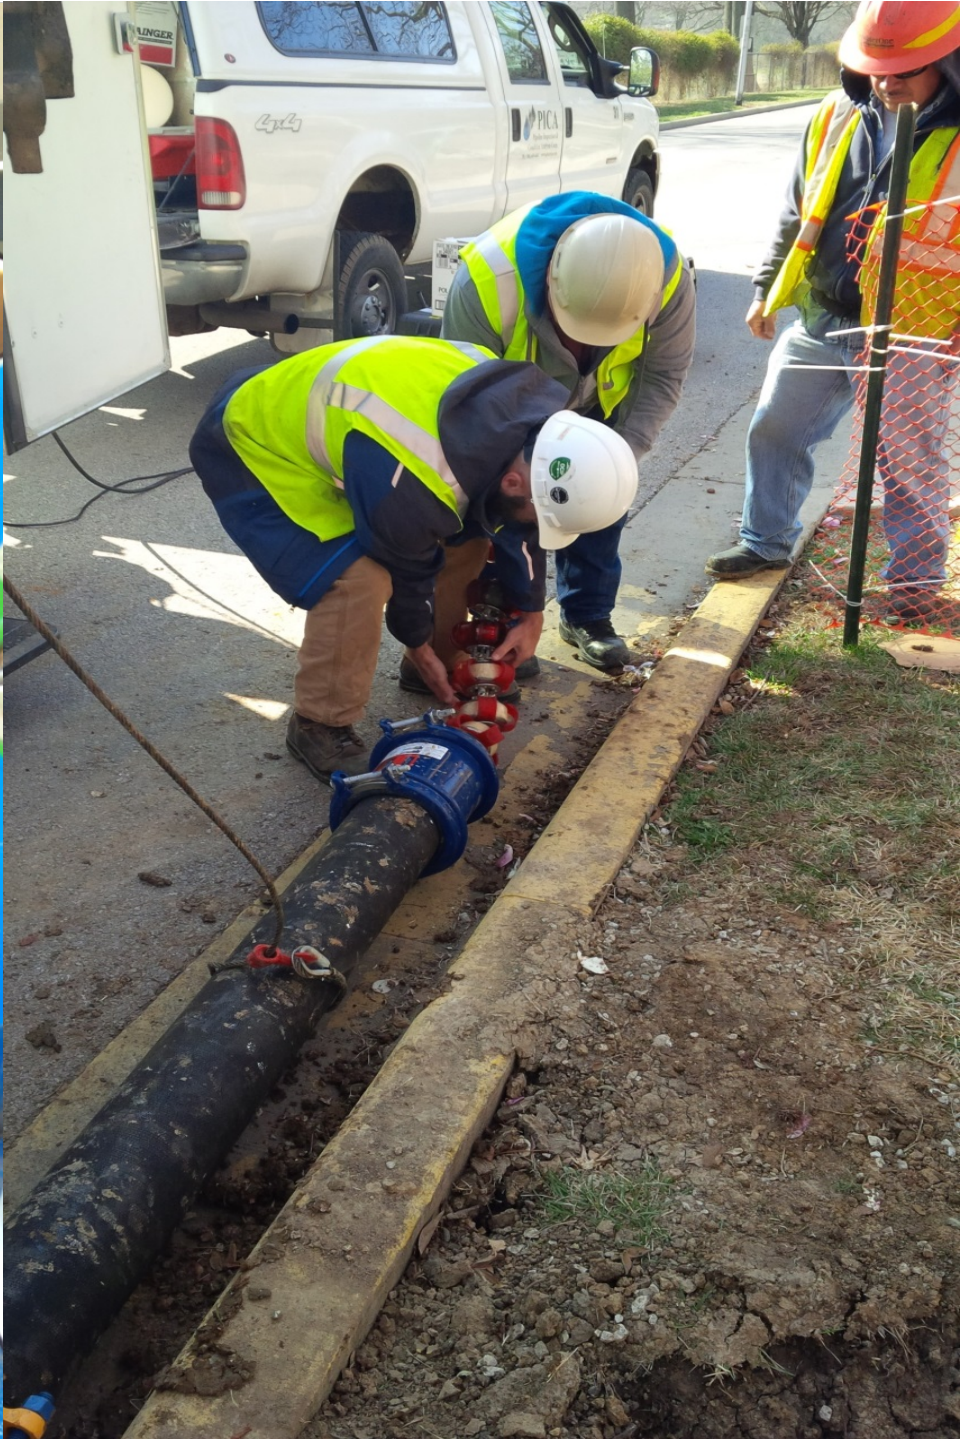
- Condition Assessment of pipe using PICA See Snake
- WRF #4437 Assess & Fix

- Average cost to replace \$130 per foot
- Project cost \$351,000
- CA indicates only half the length needs to be replaced, reduces cost by \$175,500
- CA cost ~\$26,000 (Includes WD1 labor and discounted mobilization)
- CA cost w/o discount \$36 to \$41k
- Total savings ranges from \$134.5k to \$155k

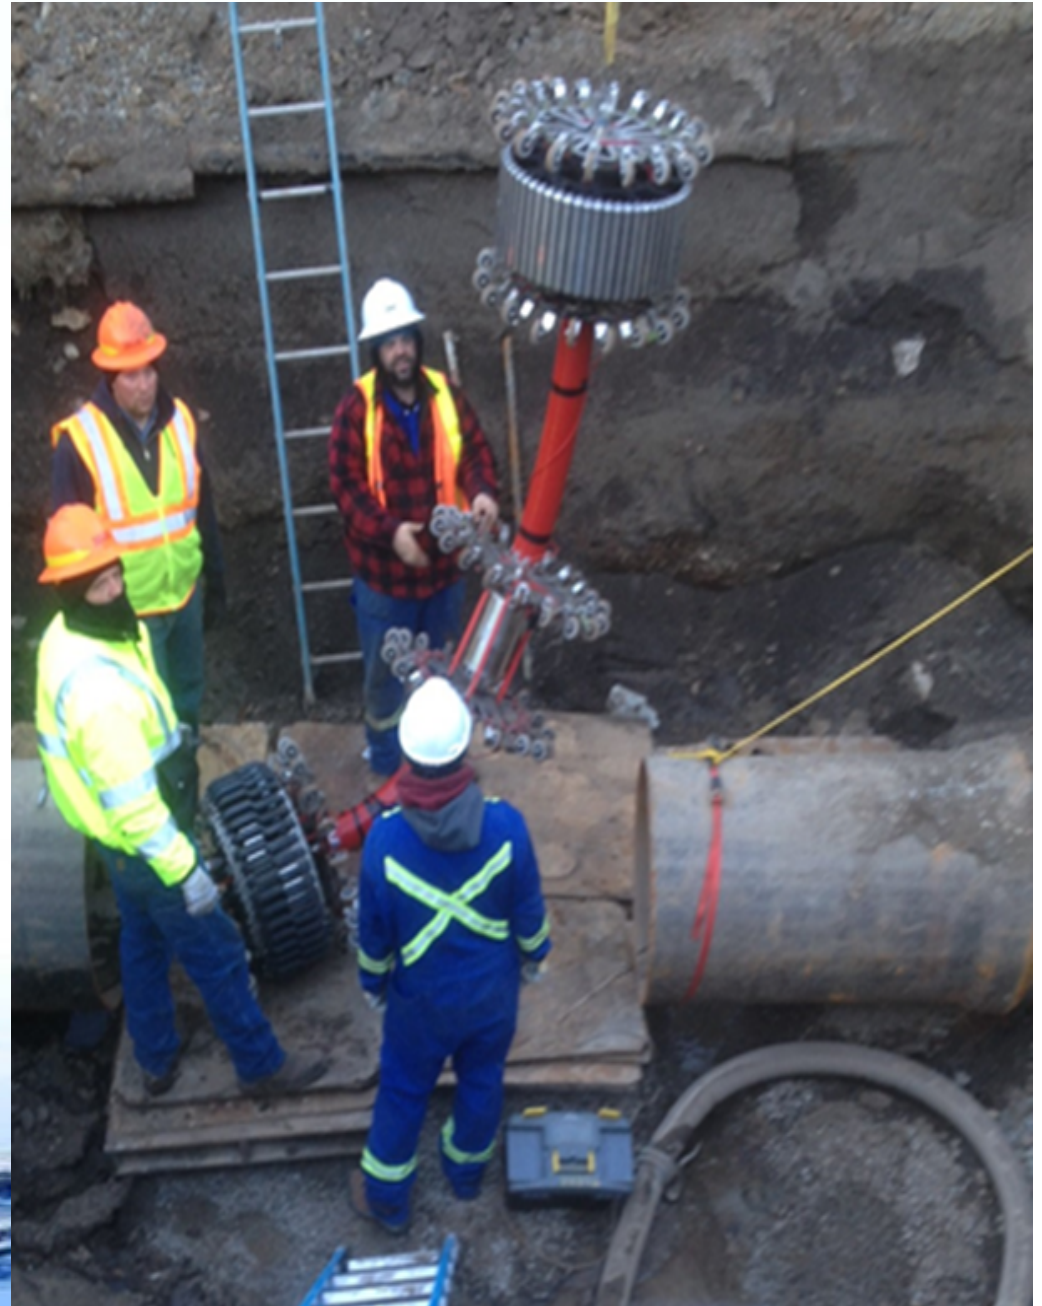
Removal of CA Tool

- 30-inch TM was in fairly poor condition, but with areas of useful life
- RFT provided detailed locations of wall loss
- 3 worst wall loss locations in each pipe section were reported

- RFP issued , received two proposals
 1. Pure Technologies
 - Magnetic Flux Leakage (MFL) provides high resolution data
 - PipeDiver tool provides baseline condition
 2. PICA Corporation
 - Free swimming See Snake uses electromagnetic Remote Field Technology (RFT) to determine the Remaining Wall Thickness (RWT)
 - Tethered See Snake
